# Manhole Inspection Summary

Manhole # S31QQ\_012MH

Insp Date: **5/11/07 9:22 AM**

**Location** Address: **2434 25TH ST**

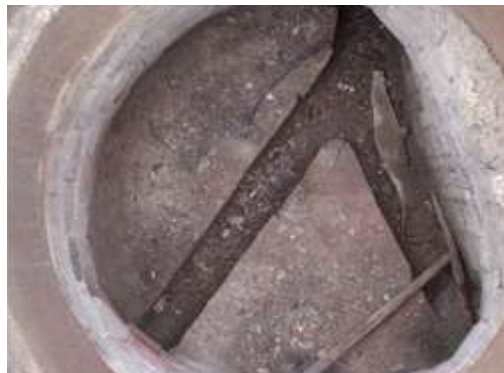
Top View

**Bench** ☒ Exists Material: **Brick** ☐ Parged ☒ **Debris** (not Condition related)  
Condition: ☒ Sound ☐ Cracked ☐ Root Intrusion ☐ Deteriorated ☐ Leaks ☐ Debris

**Channel** Material: **Brick** ☐ Parged ☒ **Debris** (not Condition related)  
Channel Exposure: **Fully Open** Junc Dist: **0** nearest .5 ft. Azimuth:  
Condition: ☒ Sound ☐ Cracked ☐ Root Intrusion ☐ Deteriorated ☐ Leaks ☐ Debris

Bench and Channel debris.

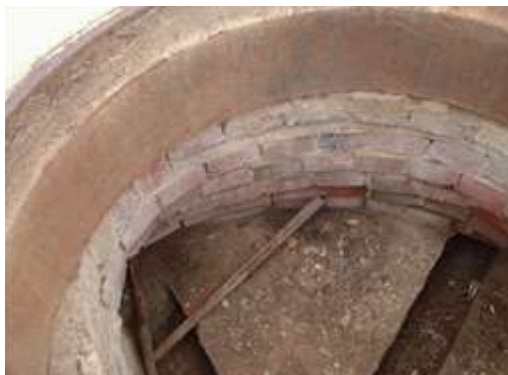
Defect

**Frame** Offset: **1** (in.) Condition: ☐ Sound ☐ Cracked ☒ **Leaks**

**Chimney / Frame Adjustment** ☒ Exists Material: **Brick** ☐ Parged Height: **6** (in.)  
Condition: ☐ Sound ☐ Cracked ☐ Root Intrusion ☐ Loose Brick ☒ **Deteriorated**  
Infiltration: ☐ None ☒ **Joint** ☐ Cracks ☒ **Mortar** ☐ Roots ☐ Wall

**Corbel** Material: **Brick** ☐ Parged Type: **Concentric/Eccentric**  
Condition: ☐ Sound ☐ Cracked ☐ Root Intrusion ☐ Loose Brick ☒ **Deteriorated**  
Infiltration: ☐ None ☐ Joint ☐ Cracks ☒ **Mortar** ☐ Roots ☐ Wall

Frame leaks. Adjustment and Corbel deterioration and infiltration - other side.

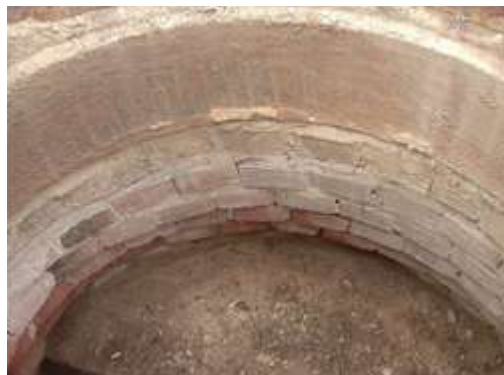
Defect

Frame leaks. Adjustment and Corbel deterioration and infiltration.

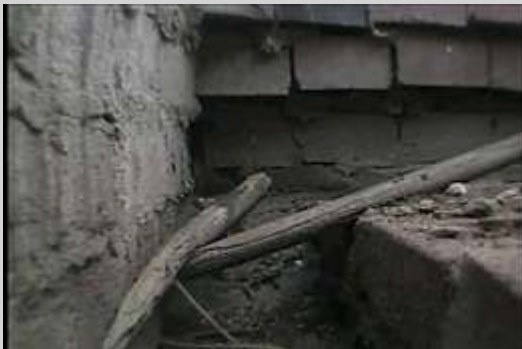
### Pipe In @ 5 O'Clock

**Barrel** Material: **Brick** ☐ Parged  
Shape: **Circular** Diameter: **42** (in.) Length: (in.)  
Condition: ☐ Sound ☐ Cracked ☐ Root Intrusion ☐ Loose Brick ☒ **Deteriorated**  
Infiltration: ☐ None ☐ Joint ☐ Cracks ☒ **Mortar** ☐ Roots ☐ Wall

Barrel deterioration and infiltration.
